ADA Compliance Program

Clark County Facilities Transition Plan Public Service Center – Accessible Entrances and Signage

Date of Survey: May 9, 2006
Conducted by: Wayne Yarnall Jesse Magana Teresa Guise Tim McVicker

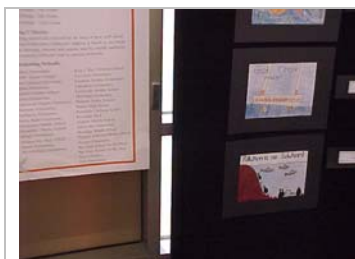
Issue: Interior Button Size and Location – East Door – First Floor Lobby

The button to operate the automatic door is rather small and is located about 10+ feet on the south side of the door.

- Install another sign which draws attention to location of push button
- Maximize the time the door will remain open

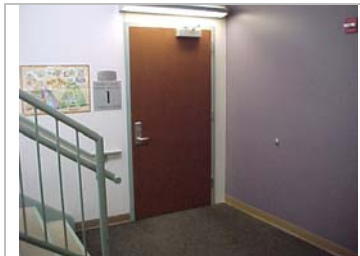
<p>Issue: Automatic Door</p> <p>Recommendation:</p> <ul style="list-style-type: none"> – Though not required, it is recommended that an automatic door be installed on the first floor east end lobby. The exterior door is automatic but the second door at the foot of the stairwell is not.

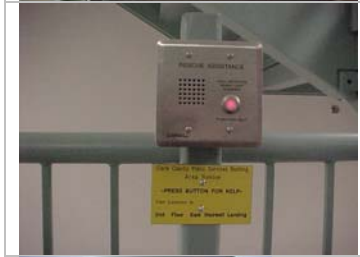
<p>Issue: Emergency Intercoms in Evacuation Refuge Areas – No operation instruction in Braille.</p> <p>ANSI 703.4.4 Position - Braille shall be below the corresponding text.</p> <p>Recommendation:</p> <ul style="list-style-type: none"> – Acquire signs for operation of intercom in Braille.

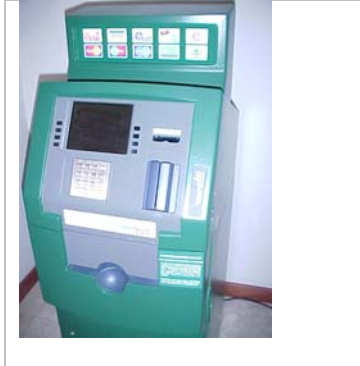
<p>Issue: No operation instruction in Braille for ATM machine on second floor</p> <p>ANSI 703.4.4 Position - Braille shall be below the corresponding text.</p> <p>Recommendation</p> <ul style="list-style-type: none"> – Acquire signs for operation of ATM in Braille.
